BOA Architecture / Government Services
Rancho Palos Verdes ADA Assessment
Facility Report with Photos

Facility ID: # 02A - City Hall Grounds

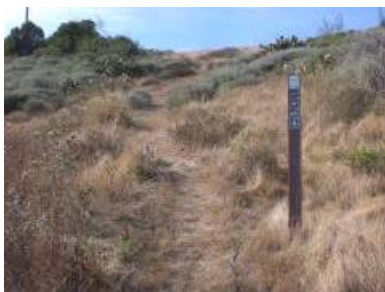
Keynote 5

30.10A - Trail Segment - Running Slope - Running slope of trail segment in the direction of travel does not comply with the following: a. 5% or less for any distance. b. From 5.1% to 8.33% for 200' maximum. c. From 8.34% to 10% for 30' maximum. d. From 10% to 12% for 10' maximum.

Existing Condition: 20%, 29.8%, 22%, 21%, 20.9%, 7.4%, 8.3%, 2.3%...

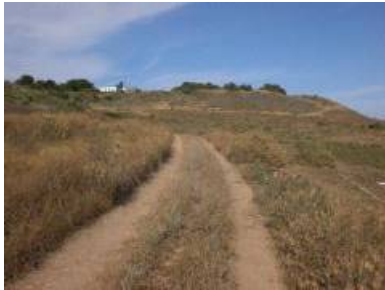
Keynote 6

30.10B - Trail Resting Space - Resting space does not comply with 1999 ADAAG Section 16.2.8 (Resting intervals shall be 60" min. in length, shall have a width at least as wide as the trail and have a slope of 5% or less in any direction. The installation of resting spaces is required as follows: Percent slope, maximum length, Rest interval: 0% to 5.0%, No restriction, No restriction; 5.1% to 8.33%, 200', Every 200'; 8.34% to 10%, 30', Every 30'; 10.1% to 12%, 10', Every 10'.)

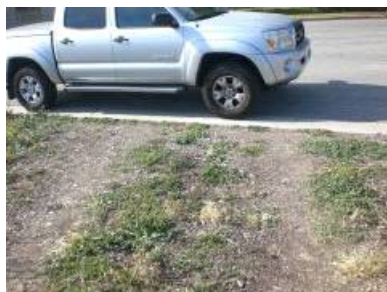
Keynote 12

03A.15 - Other - Pedestrian Accessible Route (Public Right of Way) - See Additional Comments

Existing Condition: No compliant access to Trail Park.

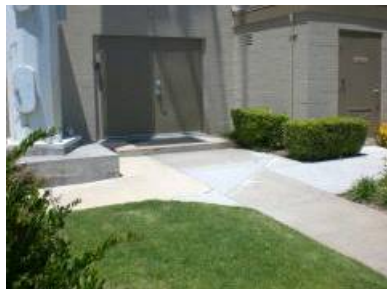
Keynote 13

03B.09 - Cross Slope - Cross slope of the accessible route of travel exceeds 1:50.

Existing Condition: 3.4% & 4.7%

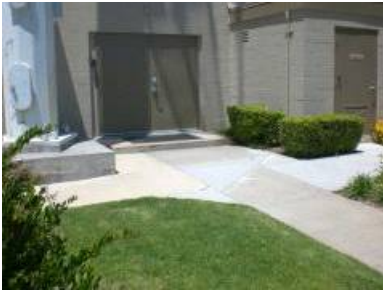
Keynote 14

03B.13 - > 1/2" Changes in Level - Curb ramps, ramps, or elevators are not used for changes in level greater than 1/2 inch. (Lifts may only be used in certain limited situations.)

Existing Condition: 5" high step

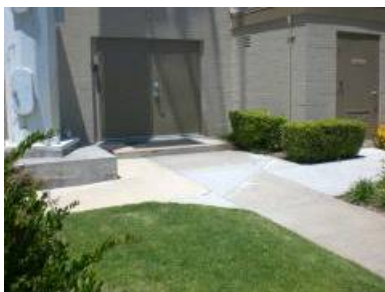
Keynote 15

10.06A - Door Maneuvering Space - Door that is not automatic or power-assisted does not have compliant maneuvering space relative to the direction of approach as shown in CBC Fig. 11B-26. (Approach // Side // Width // Depth) (Front // Pull // D + 24" * // 60") (Front // Push // D + 0" ** // 48") (Latch // Pull // D + 24" // 60") (Latch // Push // D + 24" // 44" ***) (Hinge // Pull // D + 36" // 60") (Hinge // Push // 54" **** // 44" *****) (* D + 18" at interior doors.) (** D + 12" if door has both a latch and a closer.) (***) 48" if door has closer.) (**** Measured from latch toward hinge.) (***** 48" if door has both a latch and a closer.)

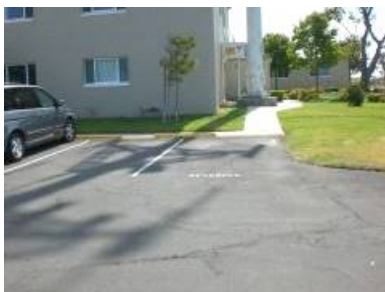
Keynote 20

03B.21 - Hazardous Vehicular Areas - Detectable Warnings - Where a walk crosses or adjoins the vehicular way and the walking surface is not separated by curbs, railings, or other elements between the pedestrian areas and vehicular areas, the boundary between the areas is not defined by a continuous detectable warning at least 36" wide complying with CBC 1121B.3.1 item 8(a). (i.e., the warning surface shall contrast visually with adjoining surfaces, either light on dark or dark on light, and shall differ from adjoining walking surfaces in resiliency or sound on cane contact. Color: yellow conforming to Federal Color No. 33538, Table IV/ Standard No. 595B. Where the color value contrast between the yellow warning and the main walking surface is less than 70 percent, a 1" wide black strip shall separate the yellow warning from the main walking surface.)

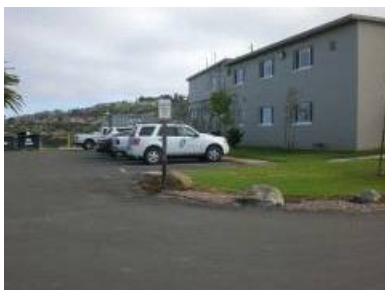
Keynote 21

01.02 - Number - Accessible Parking Spaces - Where parking spaces are provided for self-parking by employees or visitors or both, the required number of accessible parking spaces is not provided. (Note: All or some of the accessible parking spaces may be in a different location if equivalent or greater accessibility is ensured.) (Spaces required: (1 to 25 // 1) (26 to 50 // 2) (51 to 75 // 3) (76 to 100 // 4) (101 to 150 // 5) (151 to 200 // 6) (201 to 300 // 7) (301 to 400 // 8) (401 to 500 // 9) (501 to 1,000 // *) (1,000 and over // **) (*Two percent of total.) (**Twenty plus one for each 100, or fraction over 1,001.)

Existing Condition: Authorized vehicles only parking lot.

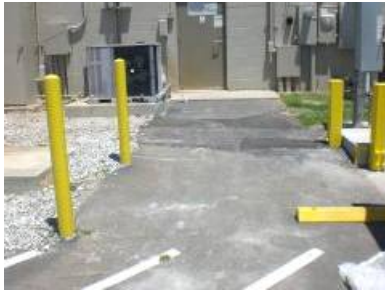
Keynote 24

03B.21 - Hazardous Vehicular Areas - Detectable Warnings - Where a walk crosses or adjoins the vehicular way and the walking surface is not separated by curbs, railings, or other elements between the pedestrian areas and vehicular areas, the boundary between the areas is not defined by a continuous detectable warning at least 36" wide complying with CBC 1121B.3.1 item 8(a). (i.e., the warning surface shall contrast visually with adjoining surfaces, either light on dark or dark on light, and shall differ from adjoining walking surfaces in resiliency or sound on cane contact. Color: yellow conforming to Federal Color No. 33538, Table IV/ Standard No. 595B. Where the color value contrast between the yellow warning and the main walking surface is less than 70 percent, a 1" wide black strip shall separate the yellow warning from the main walking surface.)

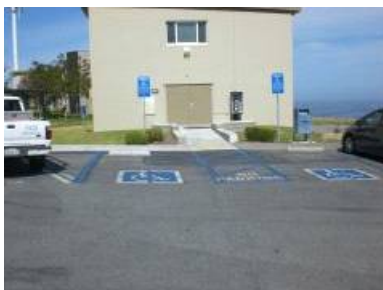
Keynote 29

Existing Condition: 16'-5" long stall.

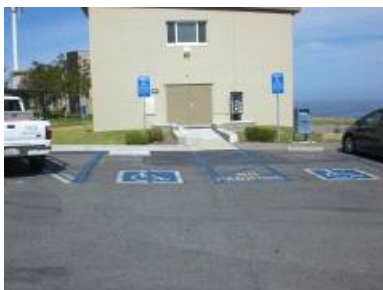
Keynote 30

Existing Condition: 4'-8" wide x 16'-8" long

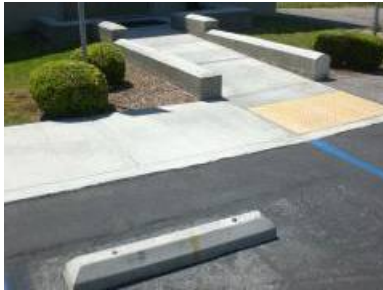
Keynote 35

03B.21 - Hazardous Vehicular Areas - Detectable Warnings - Where a walk crosses or adjoins the vehicular way and the walking surface is not separated by curbs, railings, or other elements between the pedestrian areas and vehicular areas, the boundary between the areas is not defined by a continuous detectable warning at least 36" wide complying with CBC 1121B.3.1 item 8(a). (i.e., the warning surface shall contrast visually with adjoining surfaces, either light on dark or dark on light, and shall differ from adjoining walking surfaces in resiliency or sound on cane contact. Color: yellow conforming to Federal Color No. 33538, Table IV/ Standard No. 595B. Where the color value contrast between the yellow warning and the main walking surface is less than 70 percent, a 1" wide black strip shall separate the yellow warning from the main walking surface.)

Existing Condition: No detectable warning between parking & walkway

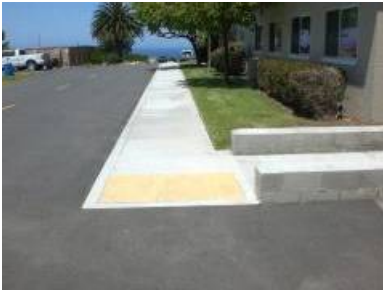
Keynote 49

03B.21 - Hazardous Vehicular Areas - Detectable Warnings - Where a walk crosses or adjoins the vehicular way and the walking surface is not separated by curbs, railings, or other elements between the pedestrian areas and vehicular areas, the boundary between the areas is not defined by a continuous detectable warning at least 36" wide complying with CBC 1121B.3.1 item 8(a). (i.e., the warning surface shall contrast visually with adjoining surfaces, either light on dark or dark on light, and shall differ from adjoining walking surfaces in resiliency or sound on cane contact. Color: yellow conforming to Federal Color No. 33538, Table IV/ Standard No. 595B. Where the color value contrast between the yellow warning and the main walking surface is less than 70 percent, a 1" wide black strip shall separate the yellow warning from the main walking surface.)

Existing Condition: No detectable warning between walkway & vehicular area at flush transition.

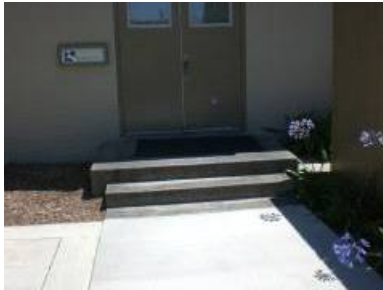
Keynote 54

10.06A - Door Maneuvering Space - Door that is not automatic or power-assisted does not have compliant maneuvering space relative to the direction of approach as shown in CBC Fig. 11B-26. (Approach // Side // Width // Depth) (Front // Pull // D + 24" * // 60") (Front // Push // D + 0" ** // 48") (Latch // Pull // D + 24" // 60") (Latch // Push // D + 24" // 44" ***) (Hinge // Pull // D + 36" // 60") (Hinge // Push // 54" **** // 44" *****) (* D + 18" at interior doors.) (** D + 12" if door has both a latch and a closer.) (***) 48" if door has closer.) (**** Measured from latch toward hinge.) (***** 48" if door has both a latch and a closer.)

Existing Condition: 48" deep landing on pull side

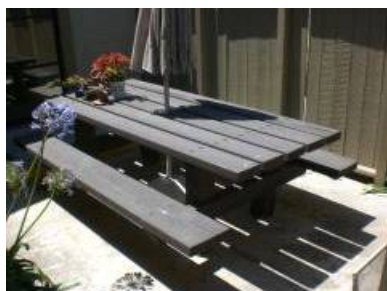
Keynote 55

Existing Condition: No compliant access to bench. Bench not accessible

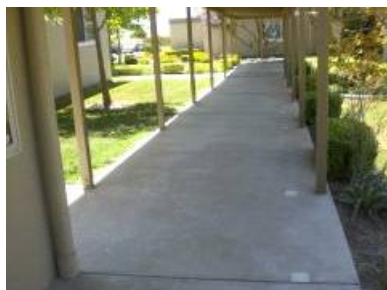
Keynote 56

Existing Condition: 2.1%, 3.3%, 3.5% at transition points.

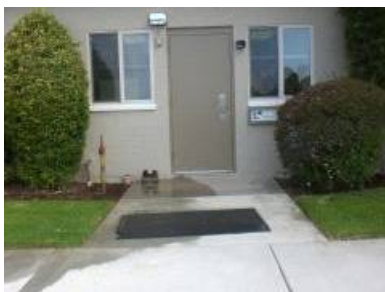
Keynote 59

10.06A - Door Maneuvering Space - Door that is not automatic or power-assisted does not have compliant maneuvering space relative to the direction of approach as shown in CBC Fig. 11B-26. (Approach // Side // Width // Depth) (Front // Pull // D + 24" * // 60") (Front // Push // D + 0" ** // 48") (Latch // Pull // D + 24" // 60") (Latch // Push // D + 24" // 44" ***) (Hinge // Pull // D + 36" // 60") (Hinge // Push // 54" **** // 44" *****) (* D + 18" at interior doors.) (** D + 12" if door has both a latch and a closer.) (***) 48" if door has closer.) (**** Measured from latch toward hinge.) (***** 48" if door has both a latch and a closer.)

Existing Condition: 23" clear at strike side.

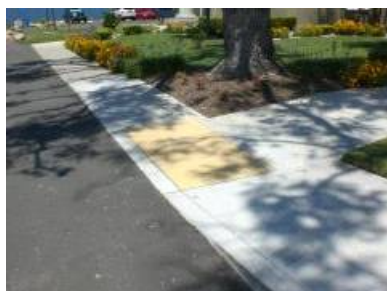
Keynote 62

03B.22 - Other - On-Site Accessible Path of Travel - See Additional Comments

Existing Condition: 35" wide domes in lieu of 36" wide.

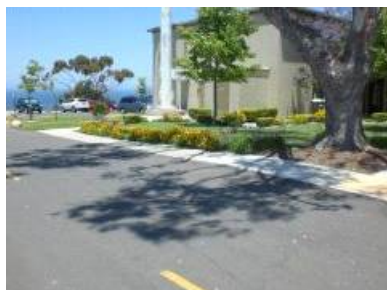
Keynote 63

03B.09 - Cross Slope - Cross slope of the accessible route of travel exceeds 1:50.

Existing Condition: 1.9%, 2.6%, & 2.7%

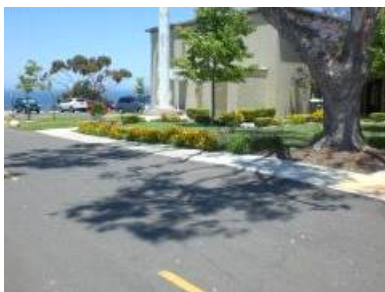
Keynote 64

03B.10 - Running Slope - Slope of the accessible route of travel exceeds 1:20.

Existing Condition: 6.5% RS & no handrails provided.

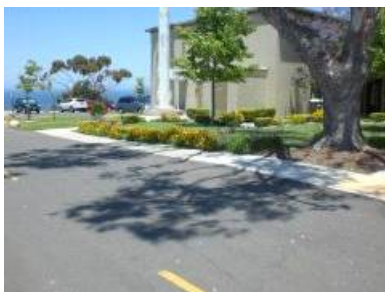
Keynote 65

03B.21 - Hazardous Vehicular Areas - Detectable Warnings - Where a walk crosses or adjoins the vehicular way and the walking surface is not separated by curbs, railings, or other elements between the pedestrian areas and vehicular areas, the boundary between the areas is not defined by a continuous detectable warning at least 36" wide complying with CBC 1121B.3.1 item 8(a). (i.e., the warning surface shall contrast visually with adjoining surfaces, either light on dark or dark on light, and shall differ from adjoining walking surfaces in resiliency or sound on cane contact. Color: yellow conforming to Federal Color No. 33538, Table IV/ Standard No. 595B. Where the color value contrast between the yellow warning and the main walking surface is less than 70 percent, a 1" wide black strip shall separate the yellow warning from the main walking surface.)

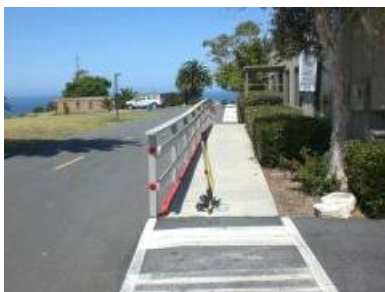
Keynote 66

03B.09 - Cross Slope - Cross slope of the accessible route of travel exceeds 1:50.

Existing Condition: 2.7%

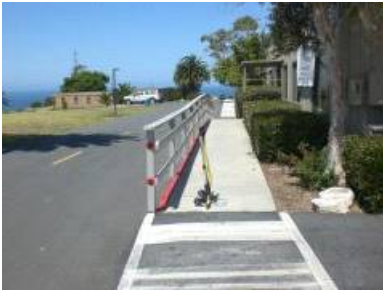
Keynote 67

03B.21 - Hazardous Vehicular Areas - Detectable Warnings - Where a walk crosses or adjoins the vehicular way and the walking surface is not separated by curbs, railings, or other elements between the pedestrian areas and vehicular areas, the boundary between the areas is not defined by a continuous detectable warning at least 36" wide complying with CBC 1121B.3.1 item 8(a). (i.e., the warning surface shall contrast visually with adjoining surfaces, either light on dark or dark on light, and shall differ from adjoining walking surfaces in resiliency or sound on cane contact. Color: yellow conforming to Federal Color No. 33538, Table IV/ Standard No. 595B. Where the color value contrast between the yellow warning and the main walking surface is less than 70 percent, a 1" wide black strip shall separate the yellow warning from the main walking surface.)

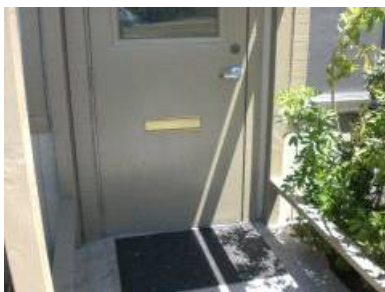
Keynote 68

10.06A - Door Maneuvering Space - Door that is not automatic or power-assisted does not have compliant maneuvering space relative to the direction of approach as shown in CBC Fig. 11B-26. (Approach // Side // Width // Depth) (Front // Pull // D + 24" * // 60") (Front // Push // D + 0" ** // 48") (Latch // Pull // D + 24" // 60") (Latch // Push // D + 24" // 44" ***) (Hinge // Pull // D + 36" // 60") (Hinge // Push // 54" **** // 44" *****) (* D + 18" at interior doors.) (** D + 12" if door has both a latch and a closer.) (***) 48" if door has closer.) (**** Measured from latch toward hinge.) (***** 48" if door has both a latch and a closer.)

Existing Condition: 6" strike clearance

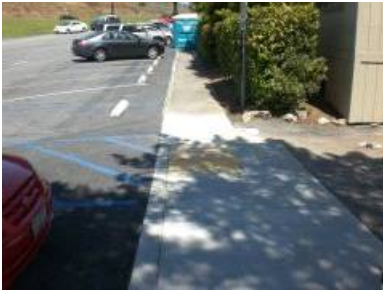
Keynote 76

03B.21 - Hazardous Vehicular Areas - Detectable Warnings - Where a walk crosses or adjoins the vehicular way and the walking surface is not separated by curbs, railings, or other elements between the pedestrian areas and vehicular areas, the boundary between the areas is not defined by a continuous detectable warning at least 36" wide complying with CBC 1121B.3.1 item 8(a). (i.e., the warning surface shall contrast visually with adjoining surfaces, either light on dark or dark on light, and shall differ from adjoining walking surfaces in resiliency or sound on cane contact. Color: yellow conforming to Federal Color No. 33538, Table IV/ Standard No. 595B. Where the color value contrast between the yellow warning and the main walking surface is less than 70 percent, a 1" wide black strip shall separate the yellow warning from the main walking surface.)

Existing Condition: 0" transition between walkway & Parking.

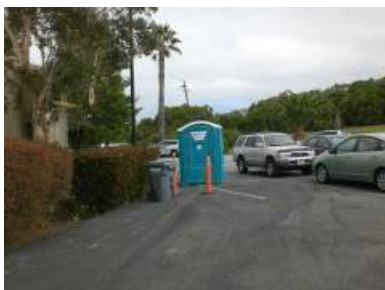
Keynote 80

Existing Condition: None provided, 4.6% CS.

004A - Asphalt Paving - Remove non-compliant pavement and replace with new asphalt paving (area as shown on the drawings). The walkway slope shall not exceed 5% along the POT and cross slope shall not exceed 2%.

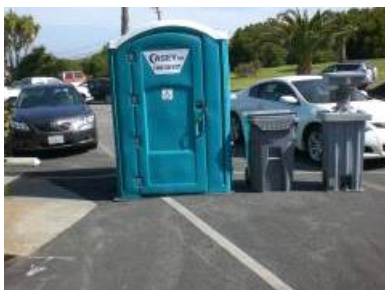
Keynote 81

Existing Condition: From an open position of 70 degrees, the door takes 1 seconds to move to a point 3" from the latch.

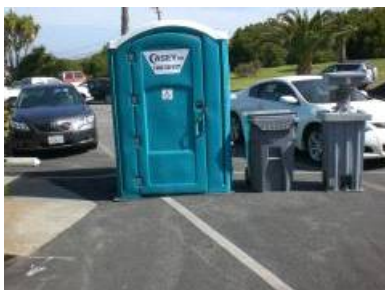
Keynote 82

Existing Condition: None provided

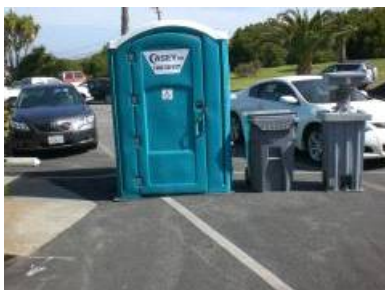
Keynote 84

Existing Condition: 4.6%

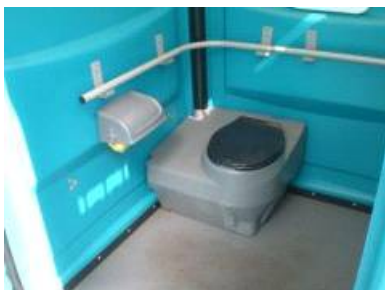
Keynote 88

Existing Condition: 13"

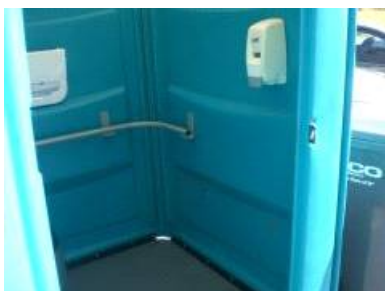
Keynote 89

Existing Condition: 45" high

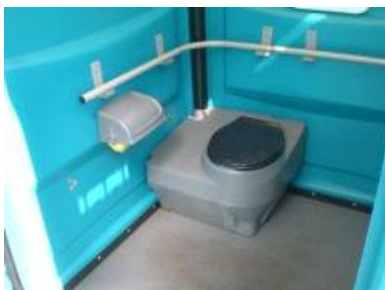
Keynote 90

Existing Condition: 37" long

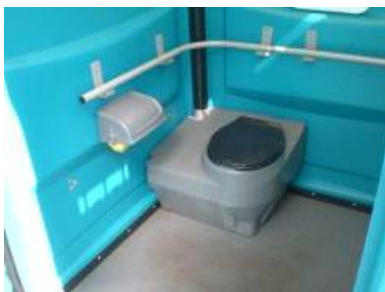
Keynote 91

Existing Condition: 34 1/2" high

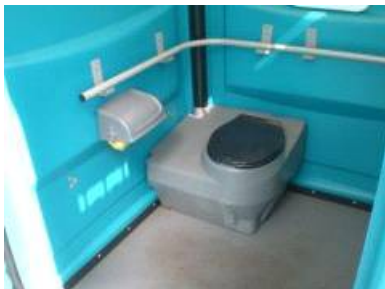
Keynote 92

Existing Condition: 1 5/8" clr.

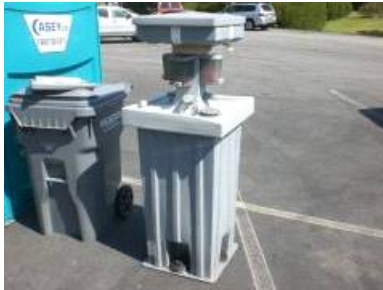
Keynote 95

Existing Condition: 39 1/2" high

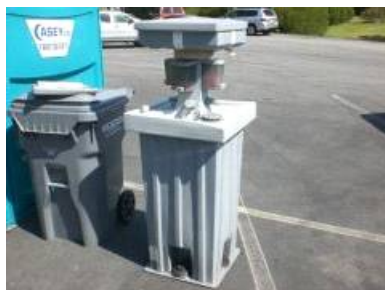
Keynote 97

Existing Condition: 53" high

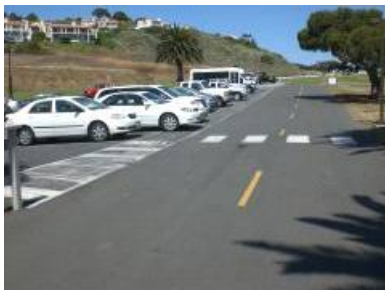
99

03B.21 - Hazardous Vehicular Areas - Detectable Warnings - Where a walk crosses or adjoins the vehicular way and the walking surface is not separated by curbs, railings, or other elements between the pedestrian areas and vehicular areas, the boundary between the areas is not defined by a continuous detectable warning at least 36" wide complying with CBC 1121B.3.1 item 8(a). (i.e., the warning surface shall contrast visually with adjoining surfaces, either light on dark or dark on light, and shall differ from adjoining walking surfaces in resiliency or sound on cane contact. Color: yellow conforming to Federal Color No. 33538, Table IV/ Standard No. 595B. Where the color value contrast between the yellow warning and the main walking surface is less than 70 percent, a 1" wide black strip shall separate the yellow warning from the main walking surface.)

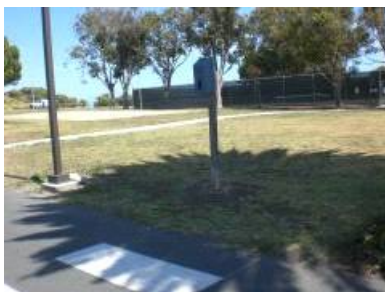
Keynote 100

03B.22 - Other - On-Site Accessible Path of Travel - See Additional Comments

Existing Condition: 60" high Doggy Bags.

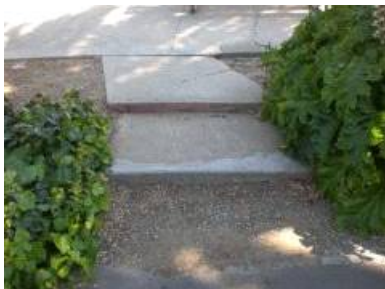
Keynote 101

08.02B - Riser Height - The risers are not uniform. OR The risers are not between 4" and 7" in height.

Existing Condition: 3" & 3 1/2" high

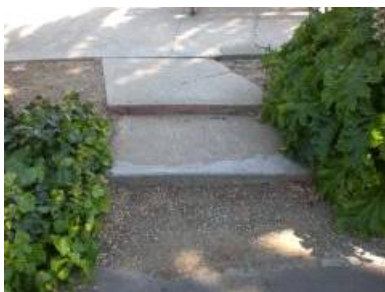
Keynote 102

08.03A - Tread Depth - The treads are not uniform. OR The treads are less than 11" deep measured from riser to riser.

Existing Condition: 29"

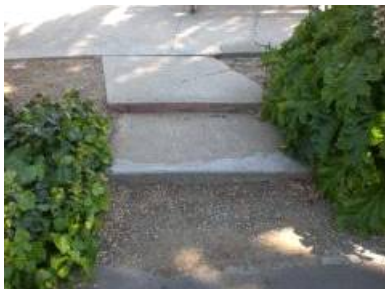
Keynote 103

03B.13 - > 1/2" Changes in Level - Curb ramps, ramps, or elevators are not used for changes in level greater than 1/2 inch. (Lifts may only be used in certain limited situations.)

Existing Condition: 3/4" high

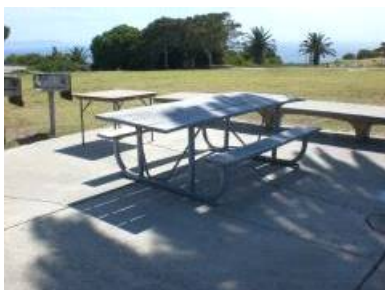
Keynote 104

30.30 - Number - Picnic Table Wheelchair Seating Spaces - Picnic table does not provide at least one wheelchair seating space. OR Where the table top perimeter exceeds 24 linear feet, the number of wheelchair seating spaces provided does not comply with the following: (Table Top Perimeter // Wheelchair Spaces) (25 LF – 44 LF // 2 spaces) (45 LF – 64 LF // 3 spaces) (65 LF – 84 LF // 4 spaces) (85 LF – 104 LF // 5 spaces)

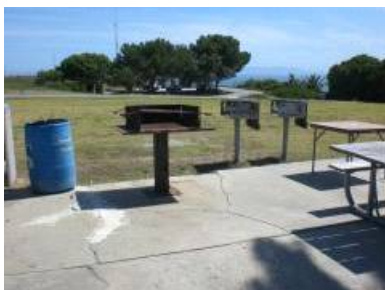
Keynote 105

03B.08 - Free Standing Protruding Objects - Free standing object(s) mounted on posts with leading edges between 27" and 80" high (such as a sign or telephone) projects more than 12" into the perpendicular route of travel. (Protruding object(s) shall not reduce required clear width of an accessible route.)

Existing Condition: BBQ protrudes > than 4" at 32" high.

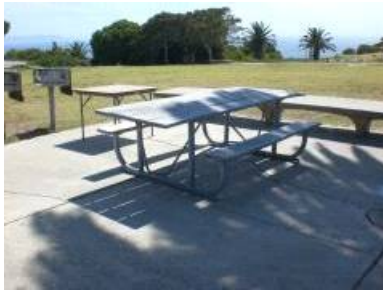
Keynote 106

30.34C - Picnic Table - Knee Space Depth - Picnic table does not provide at least 19" depth for accessible knee clearance.

Existing Condition: 17" deep

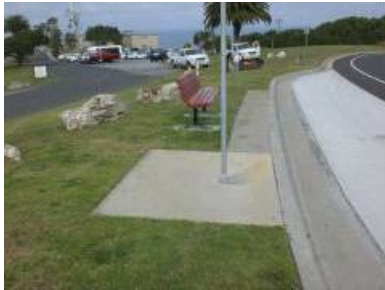
Keynote 110

Existing Condition: No compliant POT to On Site POT.

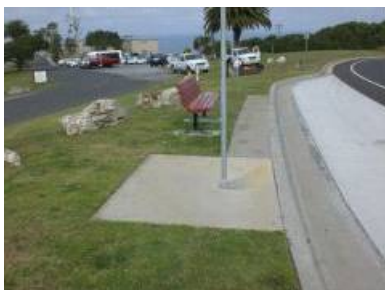
Keynote 112

Existing Condition: 4.5%

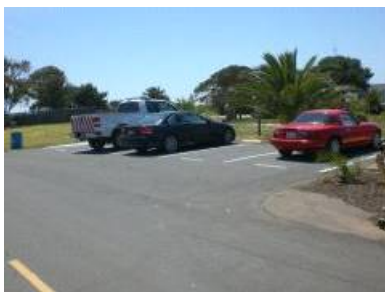
Keynote 136

01.02 - Number - Accessible Parking Spaces - Where parking spaces are provided for self-parking by employees or visitors or both, the required number of accessible parking spaces is not provided. (Note: All or some of the accessible parking spaces may be in a different location if equivalent or greater accessibility is ensured.) (Spaces required: (1 to 25 // 1) (26 to 50 // 2) (51 to 75 // 3) (76 to 100 // 4) (101 to 150 // 5) (151 to 200 // 6) (201 to 300 // 7) (301 to 400 // 8) (401 to 500 // 9) (501 to 1,000 // *) (1,000 and over // **) (*Two percent of total.) (**Twenty plus one for each 100, or fraction over 1,001.)

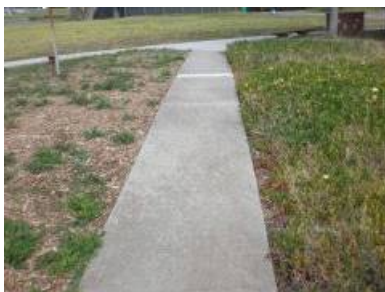
Keynote 137

03B.04 - Width - Accessible route of travel is less than 48" wide (note: 48" wide requirement does not apply to doorways or gates).

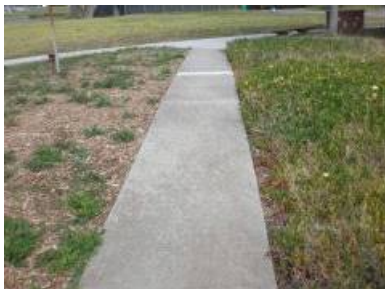
Keynote 138

03B.09 - Cross Slope - Cross slope of the accessible route of travel exceeds 1:50.

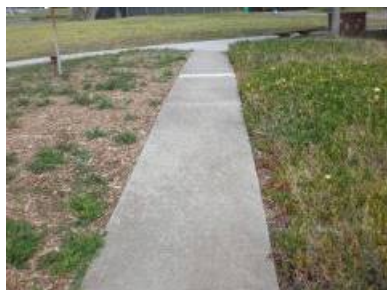
Keynote 139

03B.10 - Running Slope - Slope of the accessible route of travel exceeds 1:20.

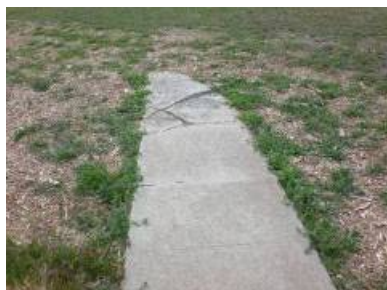
Keynote 140

03B.15 - Surface - Accessible route surfaces are not stable, firm and slip-resistant.

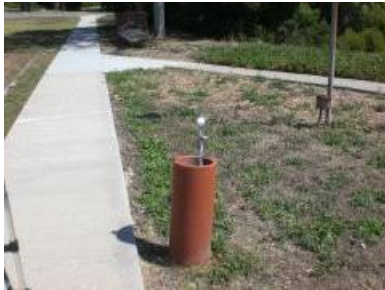
Keynote 141

05.16 - Other - Drinking Fountains - See Additional Comments

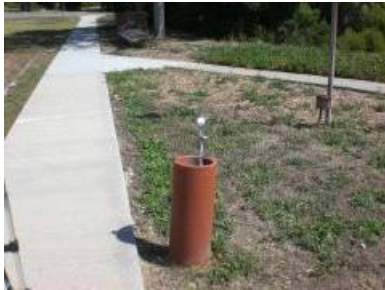
Keynote 143

03B.09 - Cross Slope - Cross slope of the accessible route of travel exceeds 1:50.
 Existing Condition: 2.8%, 3.3%, 2.9%...

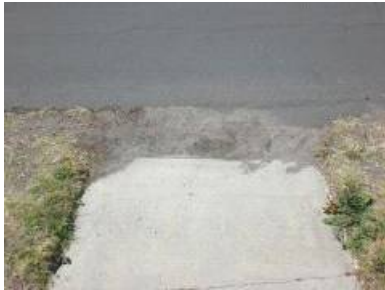
Keynote 147

03B.21 - Hazardous Vehicular Areas - Detectable Warnings - Where a walk crosses or adjoins the vehicular way and the walking surface is not separated by curbs, railings, or other elements between the pedestrian areas and vehicular areas, the boundary between the areas is not defined by a continuous detectable warning at least 36" wide complying with CBC 1121B.3.1 item 8(a). (i.e., the warning surface shall contrast visually with adjoining surfaces, either light on dark or dark on light, and shall differ from adjoining walking surfaces in resiliency or sound on cane contact. Color: yellow conforming to Federal Color No. 33538, Table IV/ Standard No. 595B. Where the color value contrast between the yellow warning and the main walking surface is less than 70 percent, a 1" wide black strip shall separate the yellow warning from the main walking surface.)

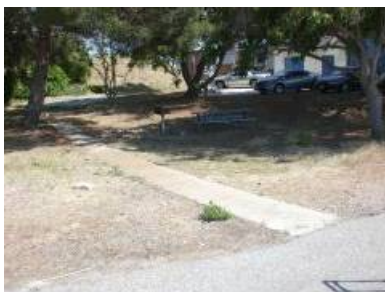
Keynote 164

30.34C - Picnic Table - Knee Space Depth - Picnic table does not provide at least 19" depth for accessible knee clearance.

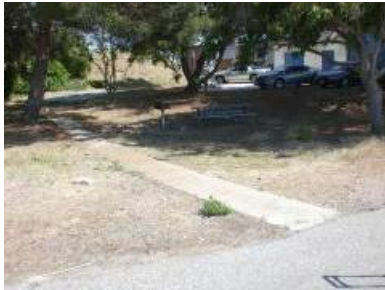
Keynote 165

03B.21 - Hazardous Vehicular Areas - Detectable Warnings - Where a walk crosses or adjoins the vehicular way and the walking surface is not separated by curbs, railings, or other elements between the pedestrian areas and vehicular areas, the boundary between the areas is not defined by a continuous detectable warning at least 36" wide complying with CBC 1121B.3.1 item 8(a). (i.e., the warning surface shall contrast visually with adjoining surfaces, either light on dark or dark on light, and shall differ from adjoining walking surfaces in resiliency or sound on cane contact. Color: yellow conforming to Federal Color No. 33538, Table IV/ Standard No. 595B. Where the color value contrast between the yellow warning and the main walking surface is less than 70 percent, a 1" wide black strip shall separate the yellow warning from the main walking surface.)
